Subject: AUDIO PANEL EDGES ARE WRINKLED / PEELING	Bulletin No: 09-026/16
	Last Issued: 04/25/2016

2016 CX-5 vehicles with VINs lower than JM3KE*****779769 (produced before February 15, 2016)

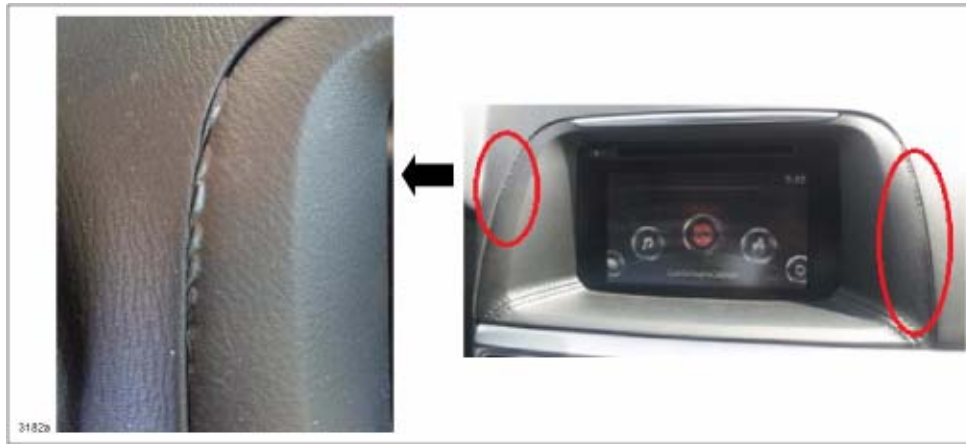
Some customers may notice that the audio panel (or center panel) is wrinkled or peeling at the edges, causing a poor appearance concern.

Protective tape has been added to the audio panel to eliminate this concern.

1. Verify the customer concern.
2. Replace the audio panel with a modified part according to the instructions on MS3 online or the Workshop Manual (section 09-17 CENTER PANEL REMOVAL/INSTALLATION).
3. Verify the repair.
