<b>Subject:</b>  RUST ON LIFTGATE OPENING	<b>Bulletin No:</b> 09-039/15
	<b>Last Issued:</b> 10/07/2015

2013-2016 CX-5 vehicles with VINs lower than JM3KE\*\*\*\*\*688079 (produced before June 7, 2015)

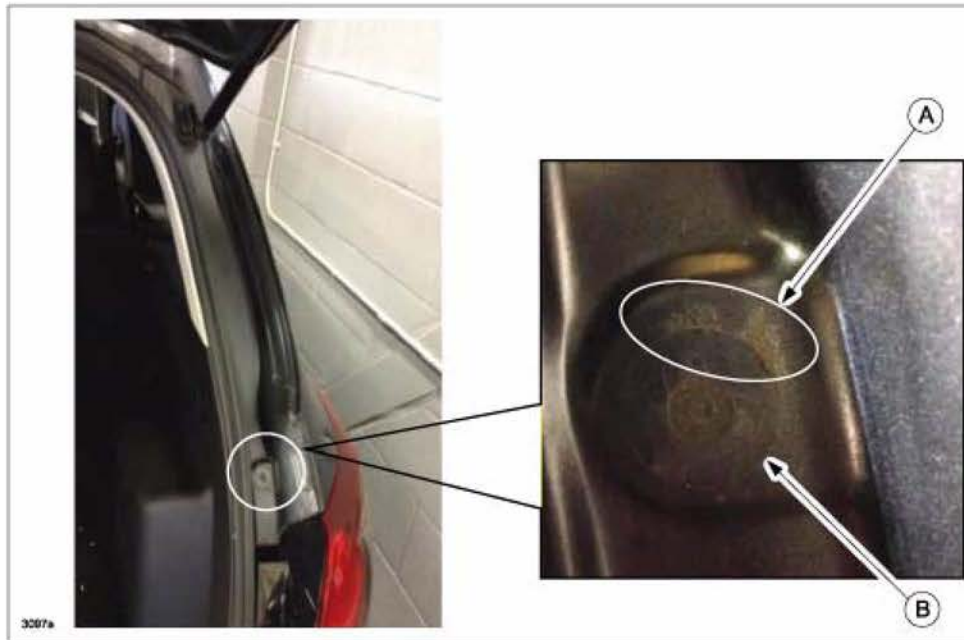
Some vehicles may exhibit rust (A) on the liftgate opening around the left and/or right side stopper (B). The paint in this area may be thinner than normal due to production variances.

Customers having this concern should have their vehicle repaired using the following repair procedure.

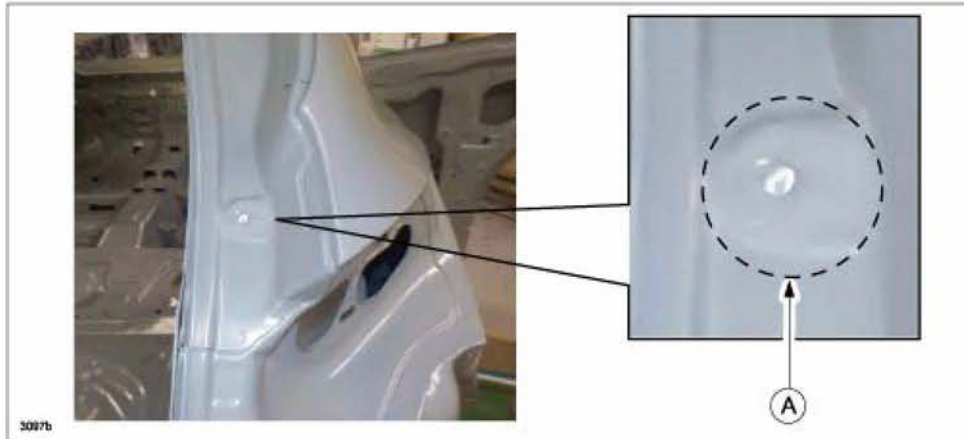
**NOTE:** The area of possible thin paint is shown below (A).

1. Verify the customer concern.
2. Repair the rust/blister damage using normal body shop repainting procedures.

3. Install a new protective film over the stopper area after the paint has fully dried.
4. Verify the repair.
