Subject: AUDIO, NAVIGATION AND PHONE CONCERNS WITH MAZDA CONNECT INFOTAINMENT SYSTEM	Bulletin No: 09-024/16
	Last Issued: 05/03/2016

MAZDA CONNECT Software Version Verification Procedure

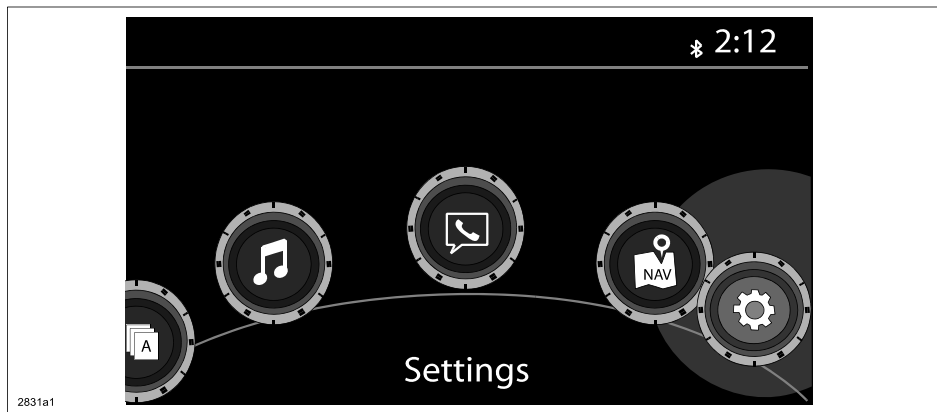
1. Select “Settings” from the Home screen to check the software version.

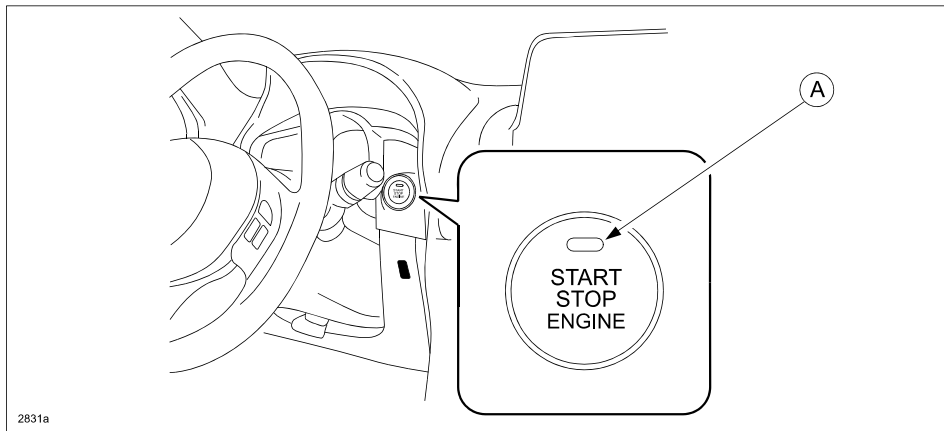
3. Remove the SD card from the slot and any USB devices if present.
4. Install the ROOM FUSE and AUDIO FUSE to the fuse block in the engine compartment (if not installed).
5. Connect battery charger (charge current maintained about 7A) to the vehicle to stabilize voltage fluctuation.
6. Press the START/STOP ENGINE push button 1 time without depressing the clutch pedal (manual transaxle) or the brake pedal (automatic transaxle), to switch the ignition position to ACC. Confirm that the push button start indicator light (A) is illuminated (amber) and the display in the instrument cluster is OFF (ignition position is in ACC).

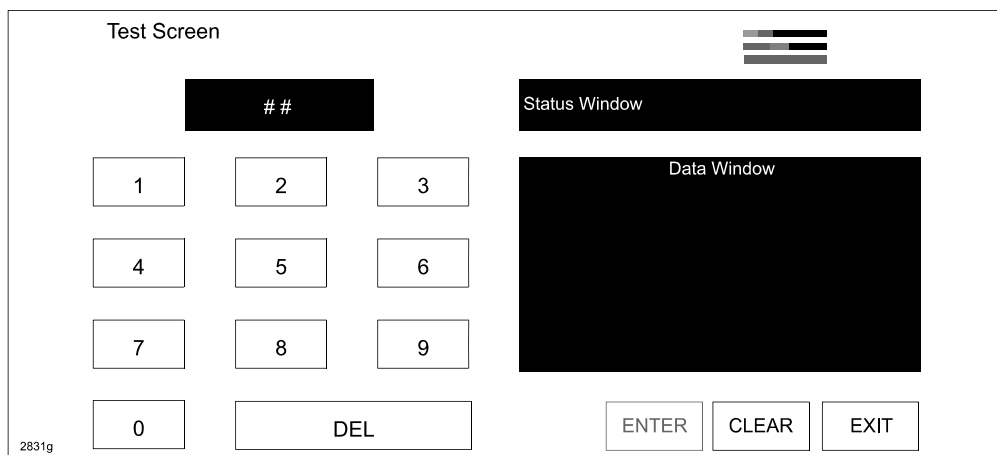
8. Press the three buttons (Music (A) + Favorites (B) + Volume Mute(C)) on the commander switch at the same time for 2-5 seconds and the Diagnostic Test Screen will appear.

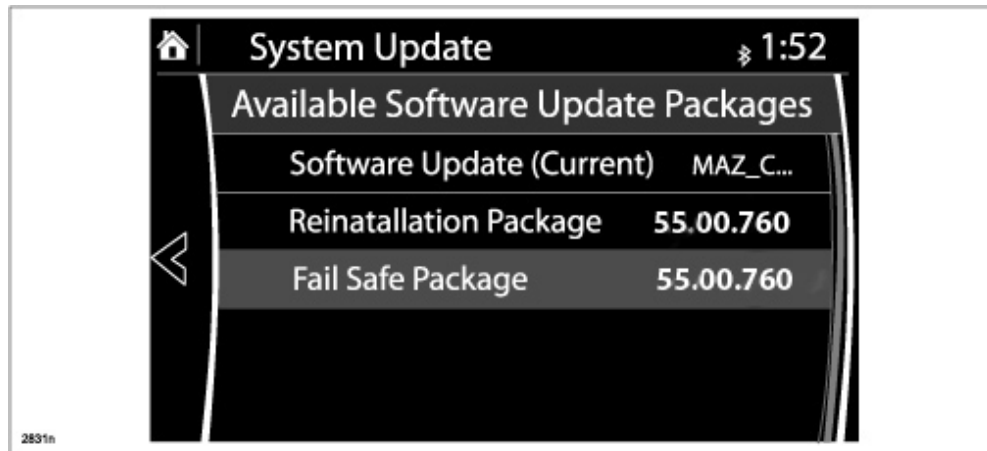
18. Select "Fail Safe Package" first using the touch screen.

CAUTION: Always do the "Fail Safe Package" first, followed by "Reinstallation Package".

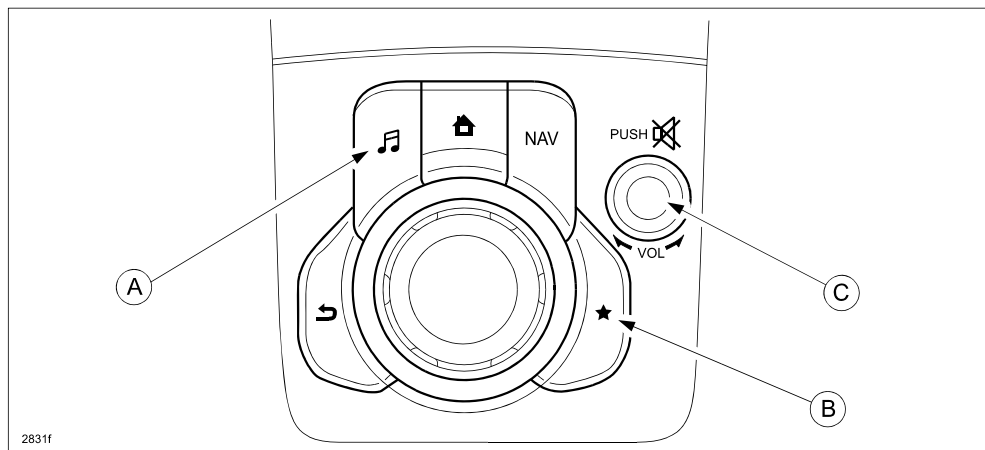
23. Press the three buttons (Music (A) + Favorites (B) + Volume Mute(C)) on the commander switch at the same time for 2-5 seconds to open the Diagnostics Test screen again.

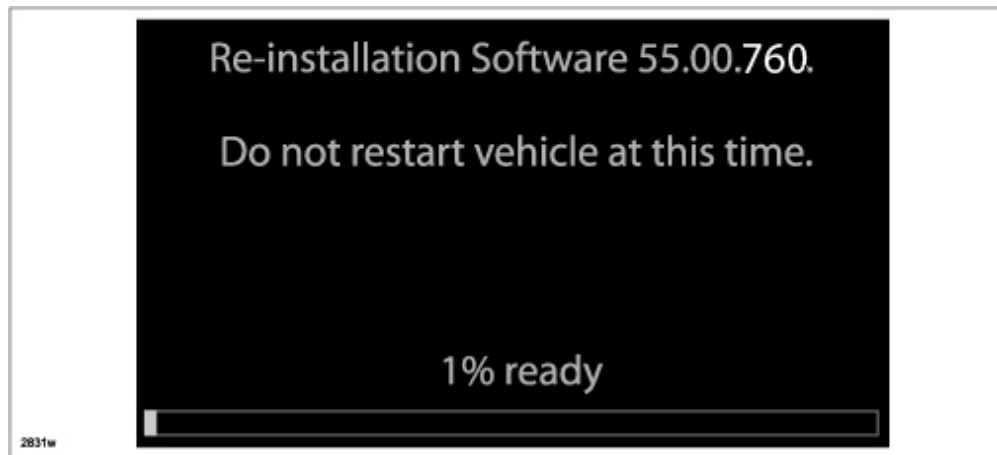
29. Reinstallation will start from 0% and as the reflashing process takes place, the progress bar will gradually increase to 100%.

NOTE: It may be difficult to read the display at times as it becomes dark, but “Do not restart vehicle at this time” is displayed.

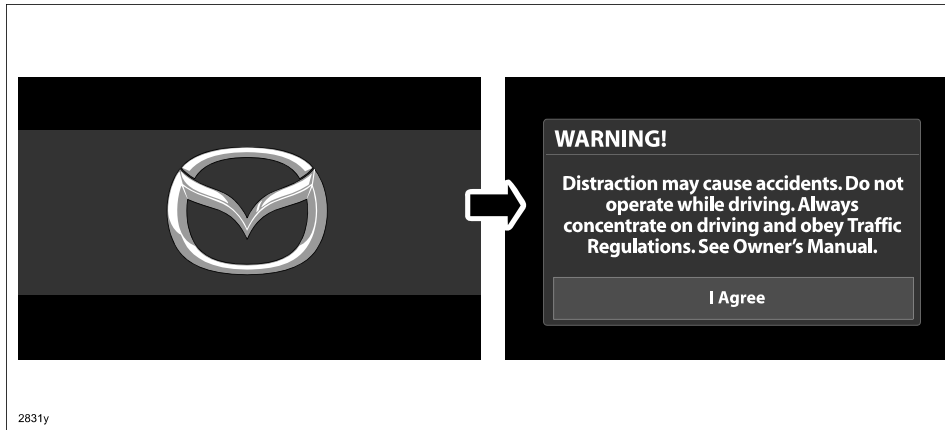
Type A: Reprogramming has already been completed. Go to next step.

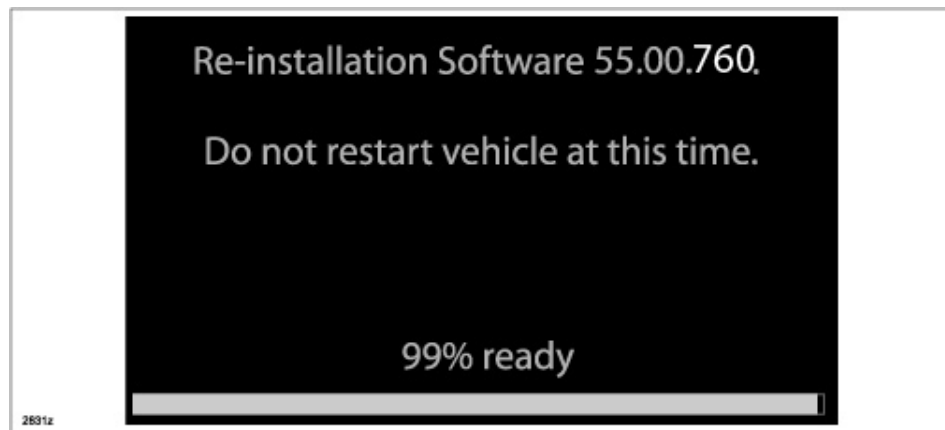
Type B: The ignition was turned "OFF" during the reflashing process. This screen will continue to be displayed until reflashing is completed. After the reflashing is completed, go to next step.

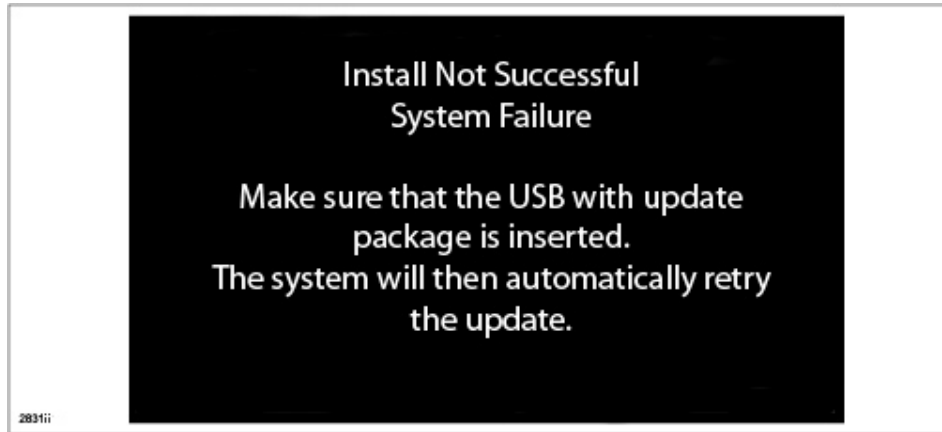
g. Confirm the screen shown below appears.

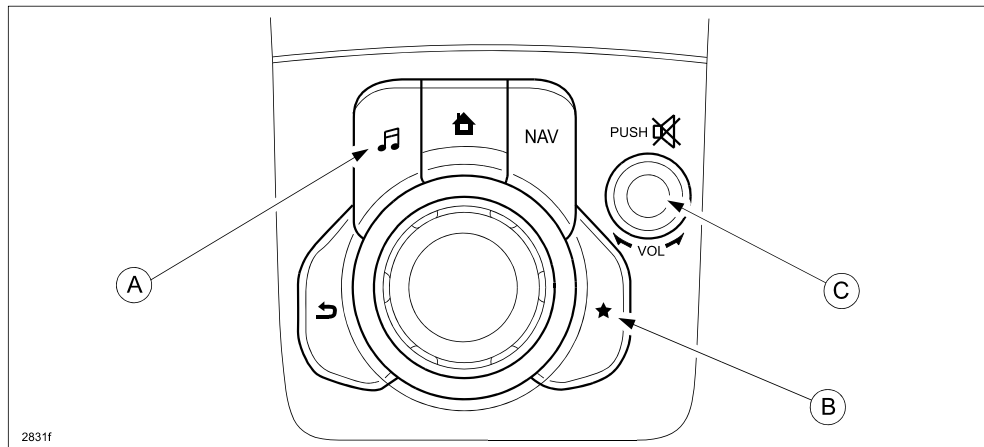
36. Press the three buttons (Music (A) + Favorites (B) + Volume Mute(C)) on the commander switch at the same time for 2-5 seconds to open the Diagnostics Test screen again.

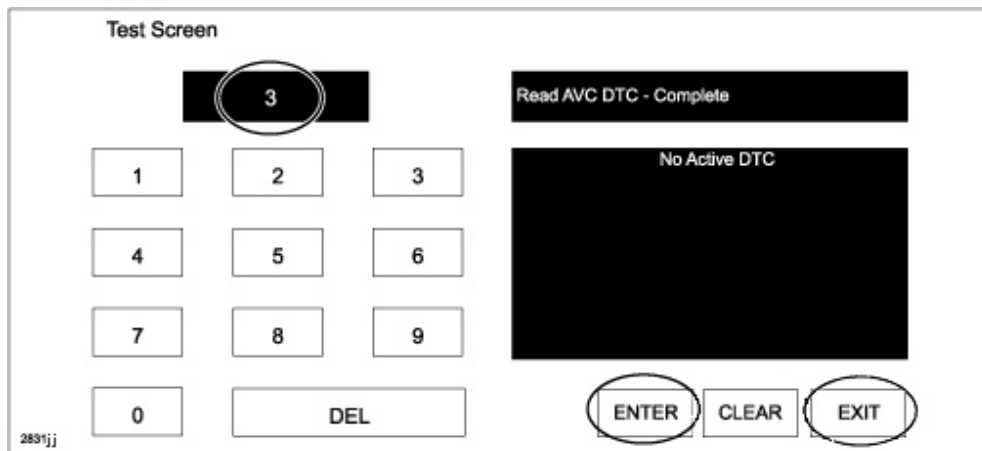
37. On the test screen, input '3' and then select "ENTER" to verify whether any DTCs (in the CMU) are active. Select "EXIT" to go to next step. If any DTC are present, diagnose it following to the Workshop Manual.
